# EAST SECOND STREET

Jamestown, New York  
14701

## BUILDING CONDITION REPORT

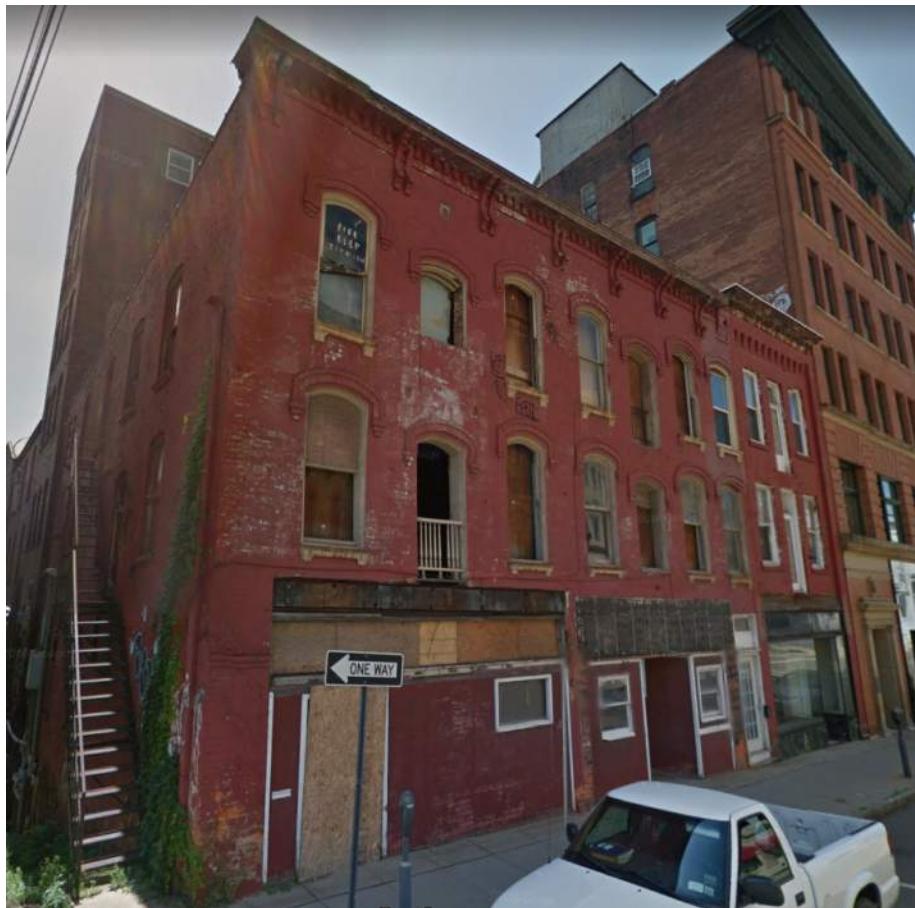
*Figure 1: Original Building*

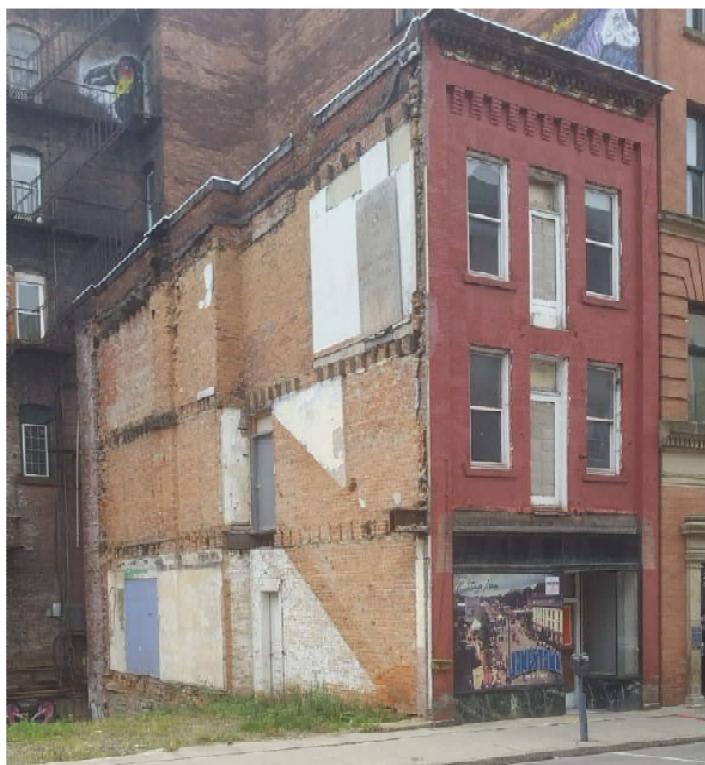
*Figure 2: Current structure*

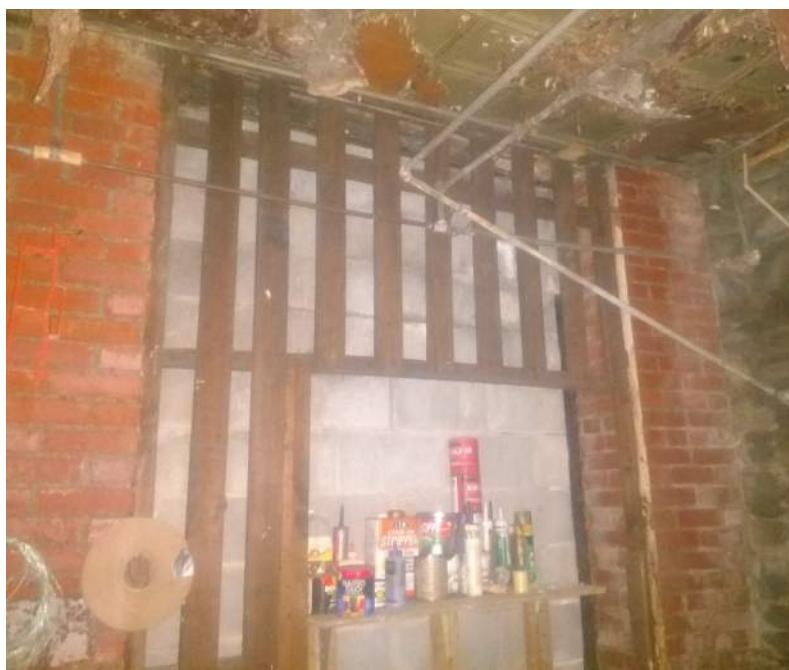
The current first floor may have actually been the second floor of the building at some point. A portion of East Second Street was filled in, bringing the street level up. This is evidenced by what appears to be the original openings at the street in what is now considered the basement of the building.

*Figure 3: Basement infill*

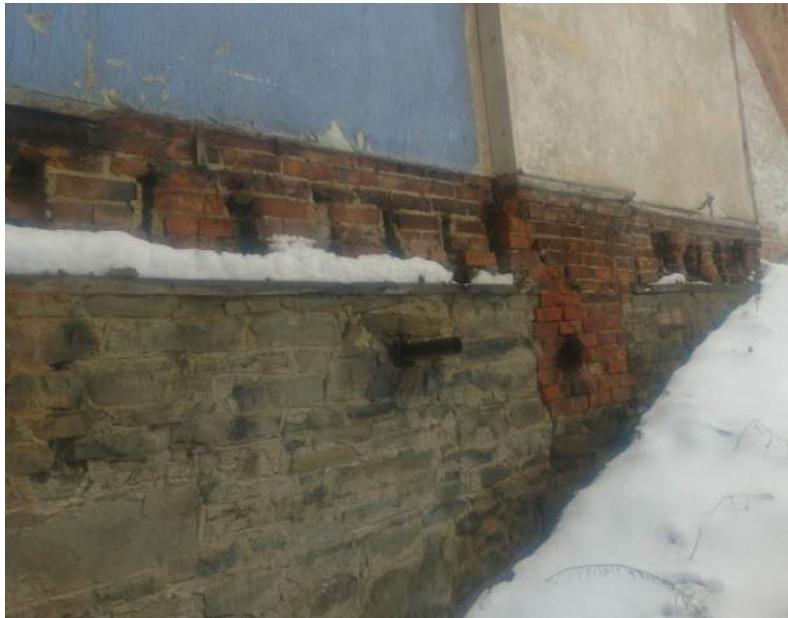
The basement walls are generally in good condition. The walls are straight and there is no mortar deterioration on the interior. There is no evidence of water infiltration through the masonry construction.

*Figure 4: Foundation/Basement wall*

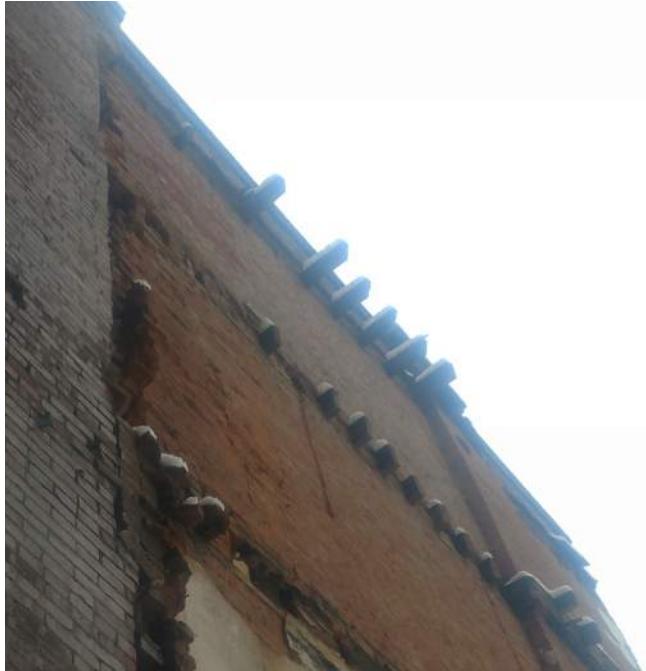
The east wall of the existing building was a common wall with the portion of the building that was previously demolished. The wood joist pockets are exposed, and portions of the demolished joists remain after the previous demolition. This wall appears to be in stable condition. However, there are portions of the wall that require repair due to the previous demolition. Additionally, at the roof level there is a portion of the wall that is missing and there is significant brick loss below this location at the third floor.

*Figure 5: Exposed wood joists*

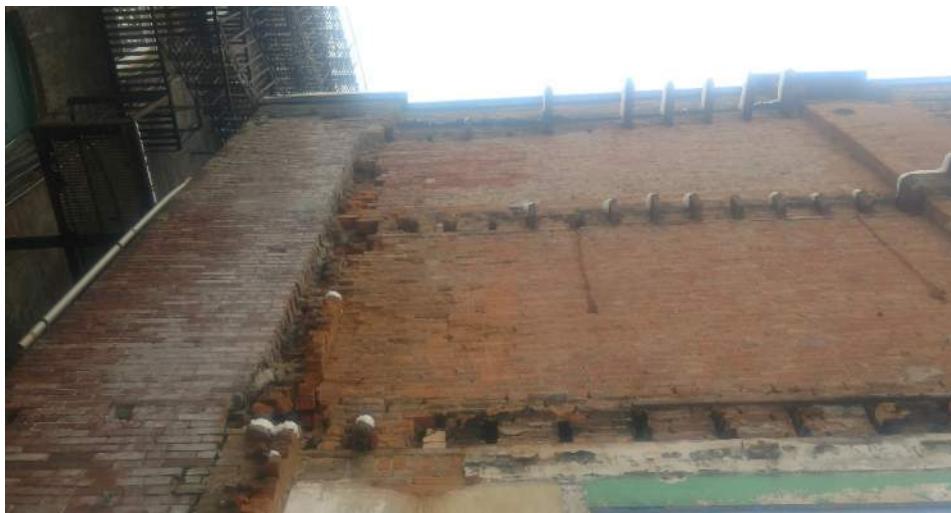
*Figure 6: Exterior at demolished portion*

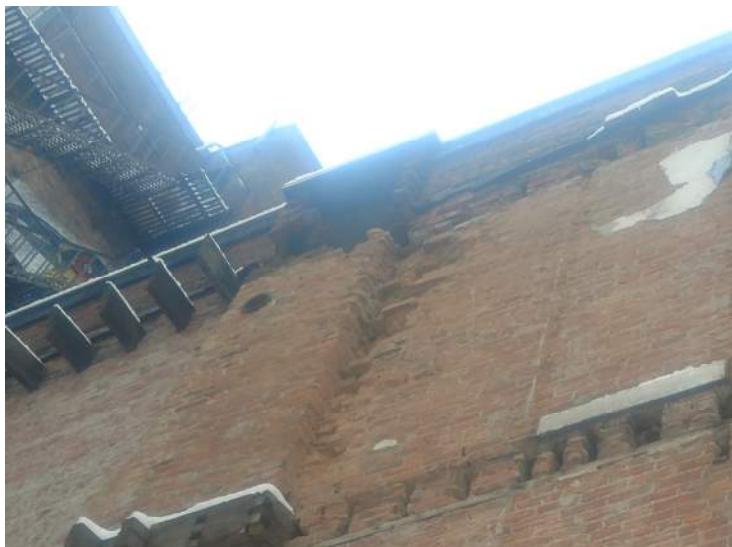
*Figure 7: Damage at Roof and Third Floor*

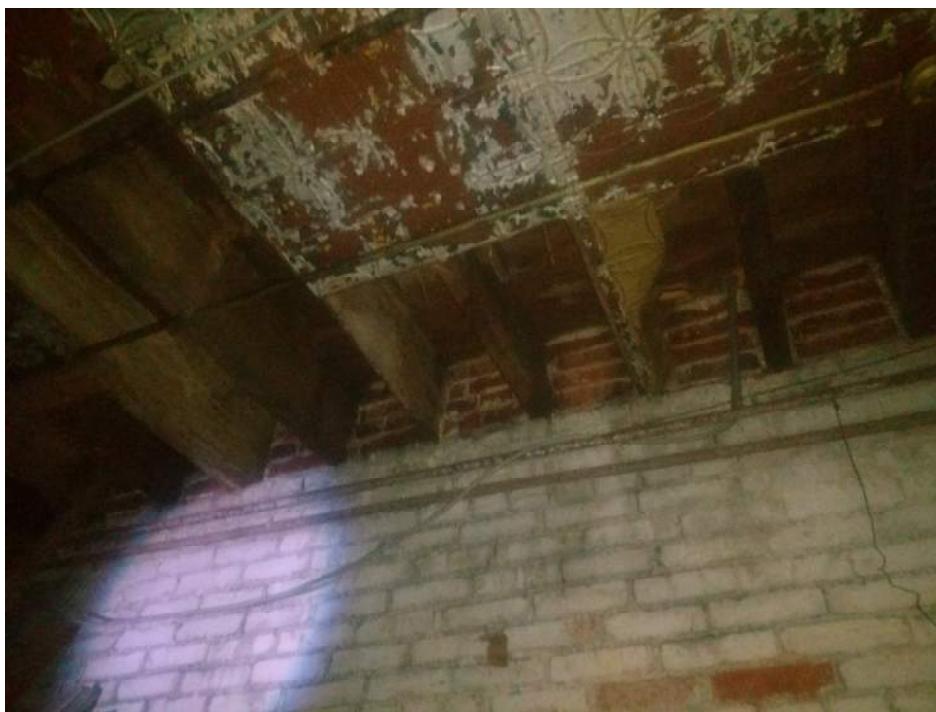
Much of the joists are still covered by the existing stamped metal ceiling panels. Where the existing metal ceiling panels have been removed, or have corroded away due to water damage, the existing joists could be viewed. The existing wood joists are generally in good condition. The first floor is in sound condition, with little evidence of excessive deflection due to potential weakening of the joists.

*Figure 8: Wood Floor Joists*

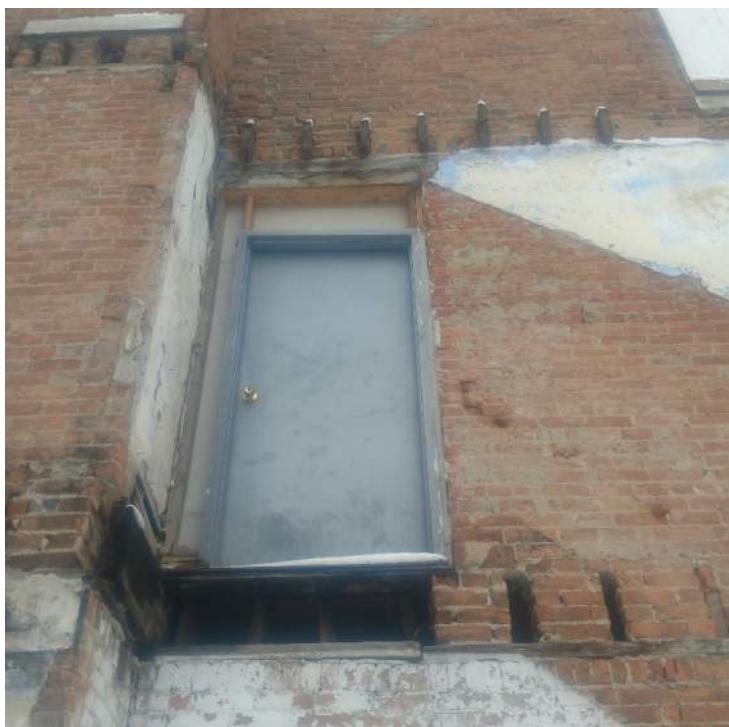
The building floors consist of wood joists with wood plank subfloor. The wood joists bear directly on the brick masonry in pockets in the walls. The second and third floors were not accessible at this time. The stair to the upper floors was removed as part of the previous demolition.

*Figure 9: Second Floor Access*

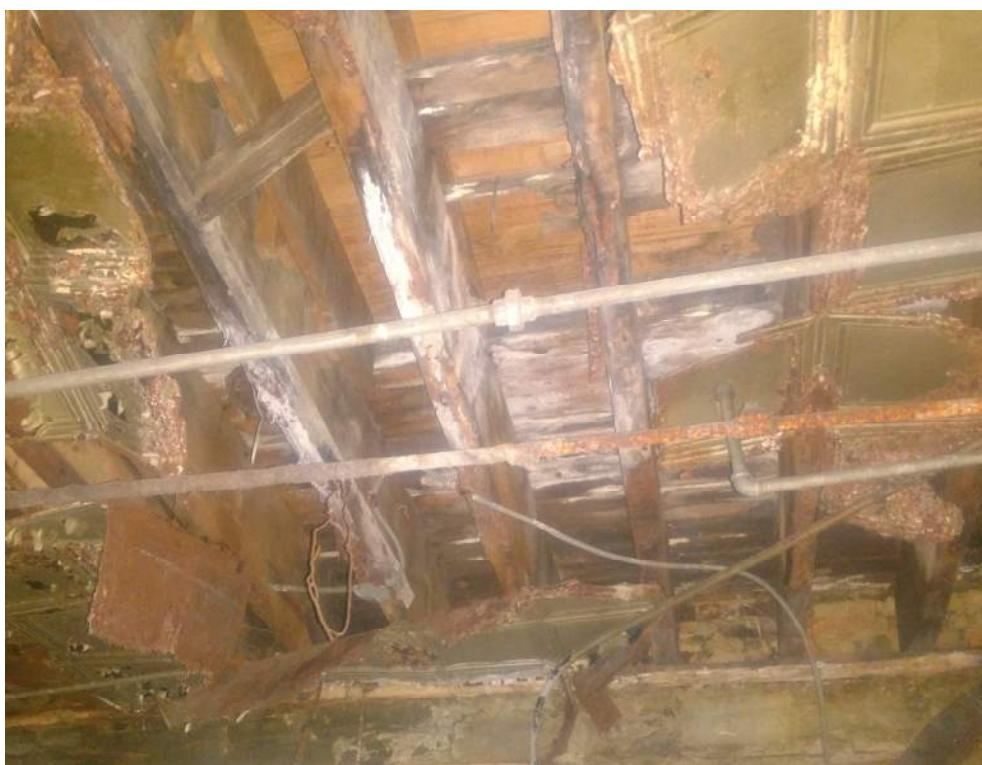
The existing floor joists are generally in good condition. There is some evidence of mild water damage in some places. It is noted that the building experienced a plumbing leak that is responsible for some of the joists getting wet. The wood joists will typically retain most of their strength after being dried, as long as permanent deterioration has not occurred.

*Figure 10: Water damaged joists*

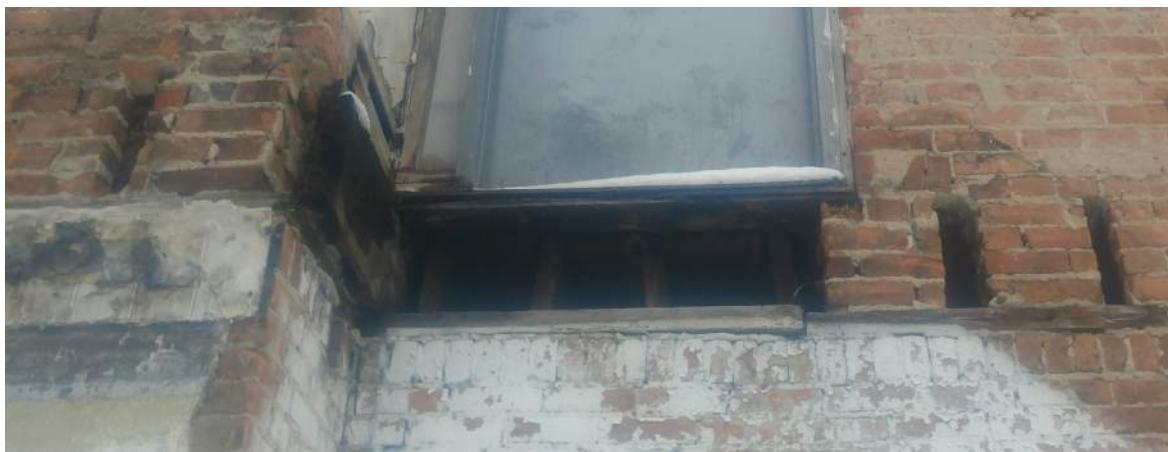
Due to the past demolition of a portion of the building, the floor joists are now exposed at the joist pockets. Continued exposure of the bearing ends of the existing floor joists has the potential to cause permanent damage to the existing floor joists.

*Figure 11: Exposed Floor Joists*

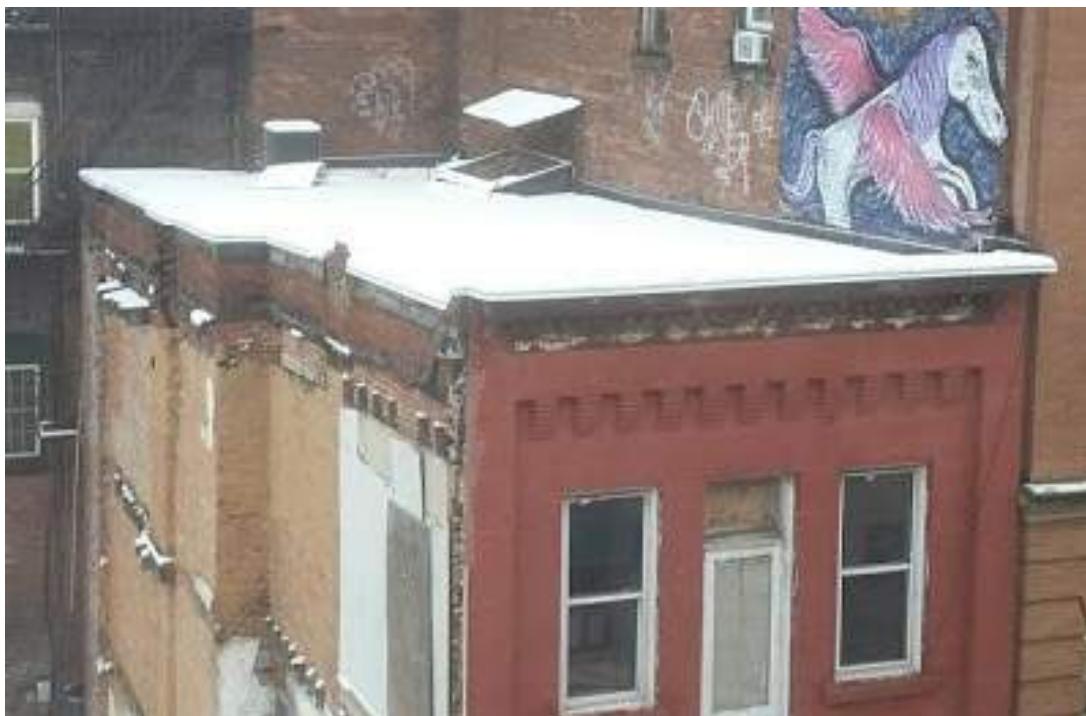
The roof is constructed in a similar fashion as the existing floors of the building. This is evidenced by the portion of roof joists remaining along the wall where the adjacent portion of the building was previously demolished. The roof was also reviewed from the taller building across the street. The roof was covered by snow, but showed no signs of distress, or large deflections indicating that the existing roof joists are likely in decent condition.

*Figure 12: Roof from building across the street*
